# Bridgefield Estate Stage 10A

## GITA Inspection Verification Report

**Report Number** D21711A V1

**Version Release Date** 7 Dec 2021

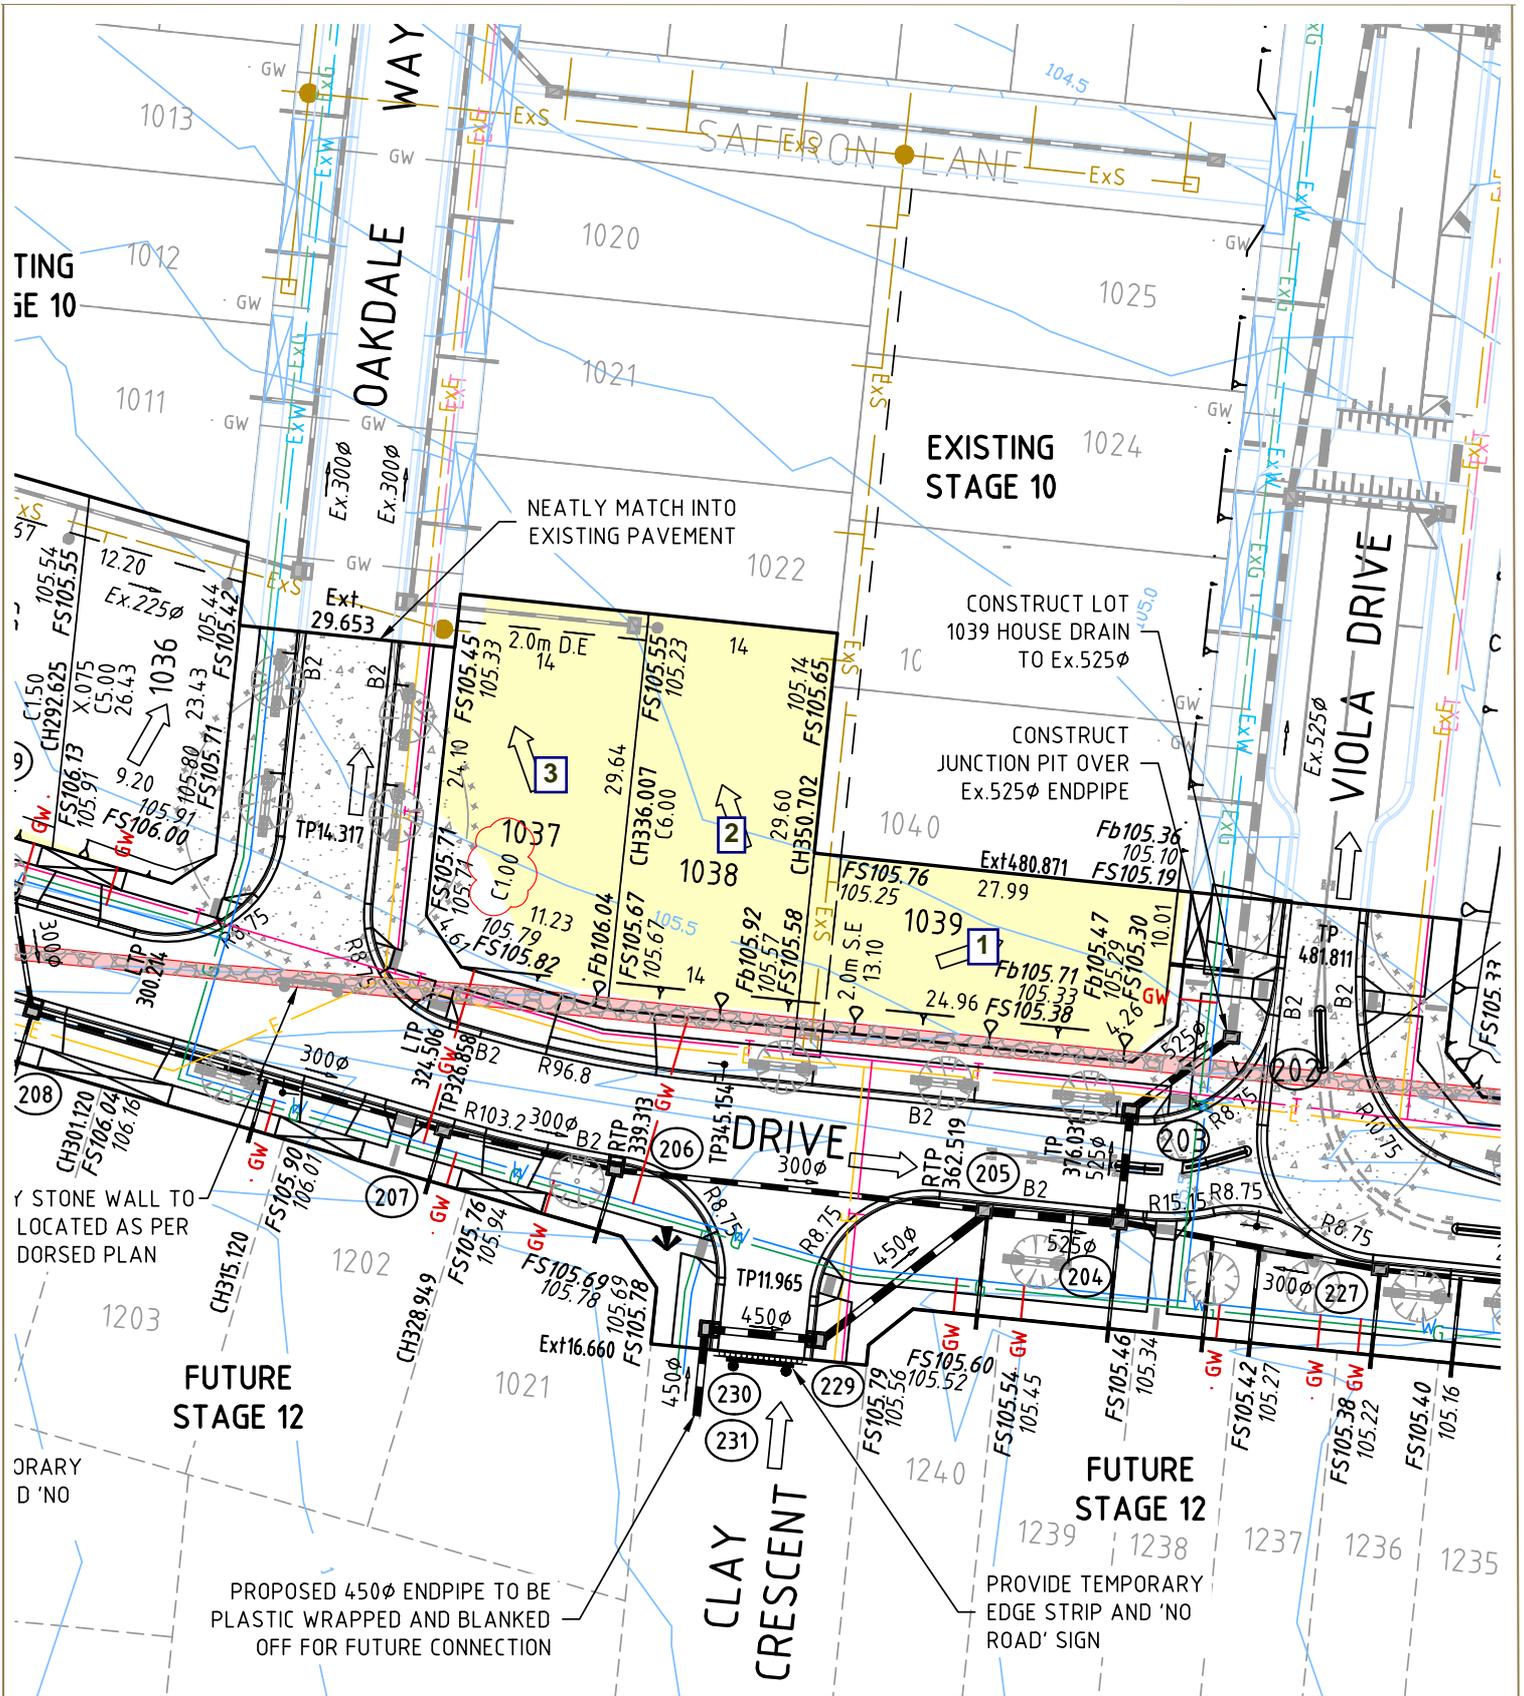
**Test Location Plan**  
not to scale

Compaction Verification testing is summarized in a detailed test register with test certificates attached provided in Appendix 2: *Compaction Test Register and Test Certificates*. A test location

plan (D21711D1, Appendix 1) providing a schematic of test locations across the extent of scope of works for every placed layer of fill is also documented.
